## **28-Year-Old Man Dies after Falling with Lift**

### **Incident Number: 03KY056**

**Subject: 28-Year-Old Sound Technician Dies after Falling from Lift**

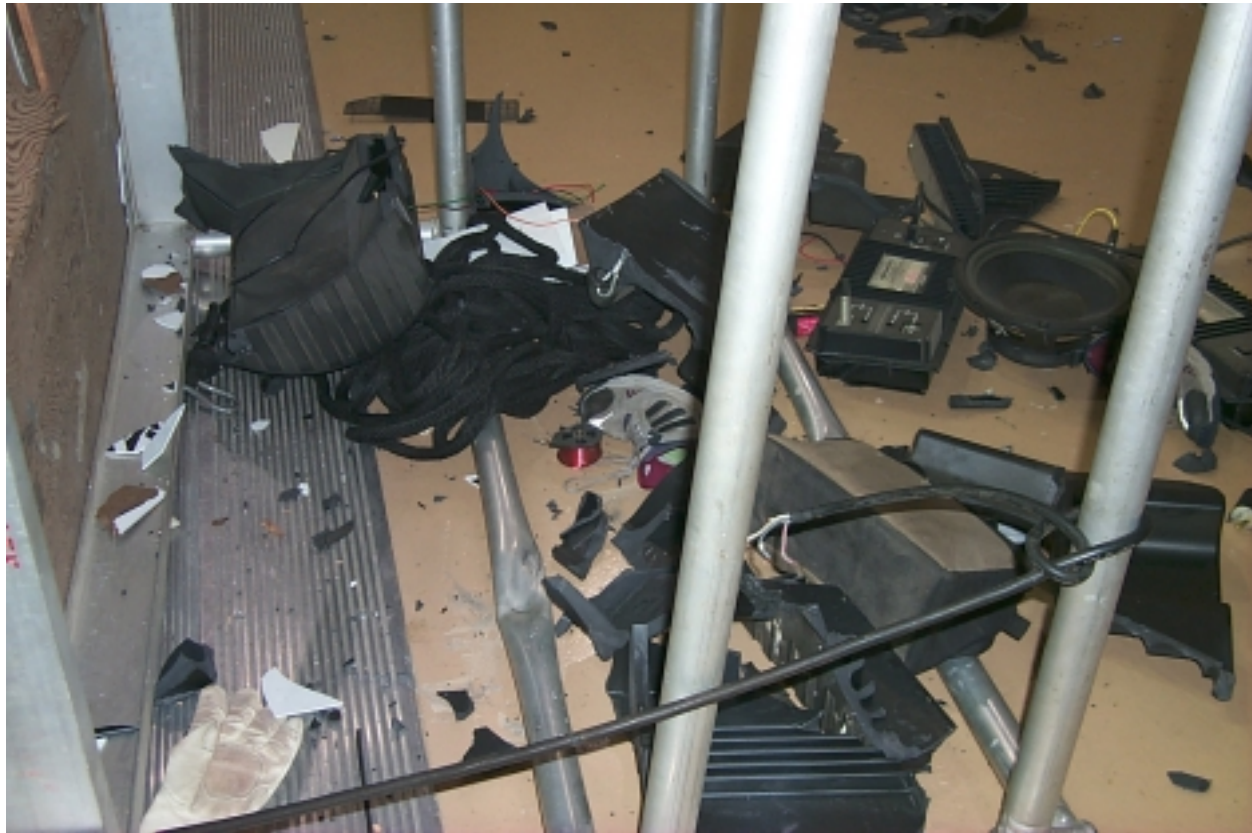
**Telescoping lift basket that fell with the two workers and a speaker inside**
